## RESIDENTIAL INSPECTION

123 Main St  
Houston TX 77001

# PROPERTY INSPECTION REPORT

Concerning: 123 Main St, Houston TX 77001

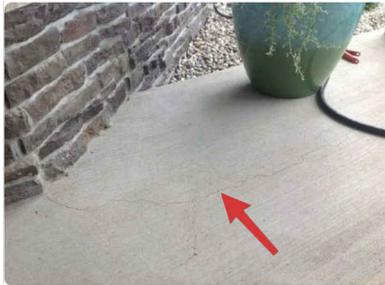
There is evidence of possible prior foundation repair and minor cracking on the front porch. This is not necessarily cause for concern, but should be monitored.

Minor hairline cracks are normal.  
These are not a cause for concern

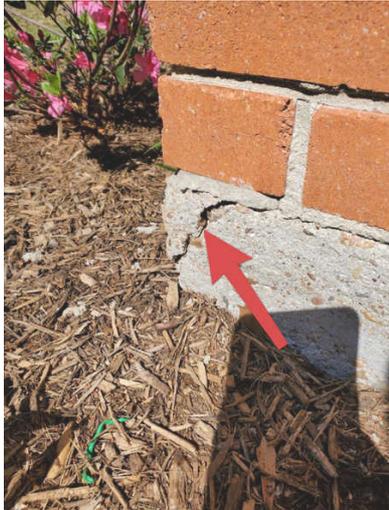
**1: Corner pop**

Corner pops are common with poured concrete slabs. While they may look bad, they are rarely a serious issue. This corner pop appears to be only cosmetic and does not appear to be affecting the structure of the foundation or the walls at all. I recommend monitoring the corners of the slab top ensure they don't get worse over time.

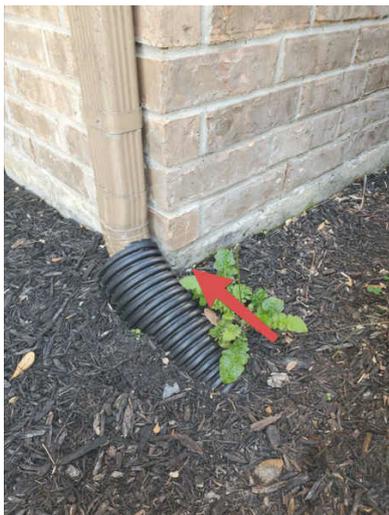
**1: Insufficient clearance from foundation to grade**

It is recommended there be at least 4" of clearance from brick siding to the ground and at least 6" for other types of siding. It is recommended to remove some of the dirt and vegetation from around the foundation to allow for proper drainage.

There should be a minimum of 4 inches of clearance groin the ground to the brick.

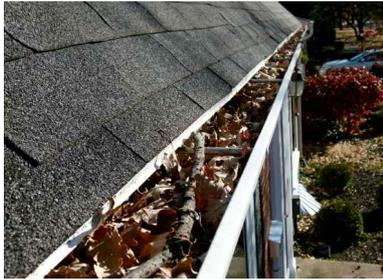
The gutters/downspouts were full of debris and leaves. If left in this state water can fill the gutters and damage the eaves of the roof. Water can also overflow the gutters and spill out directly next to the foundation, potentially causing damage.

Leaves should be removed from gutters

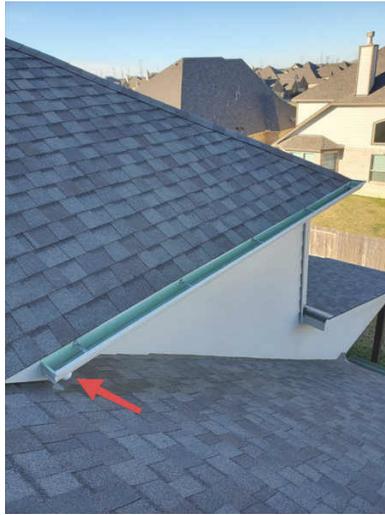
The gutters from the upper section of roof were discharging onto the lower sections of roof. This will lead to the lower sections of roof wearing out prematurely as they are having to handle the entire water load from the upper sections of roof. There is a photo attached in this section that depicts what this will do to your roof over time. It is recommended that all gutters be routed to the ground and discharge at least 5 feet away from your foundation.

Gutters from upper section of roof are discharging into lower section of roof. This will wear out the lower roof prematurely

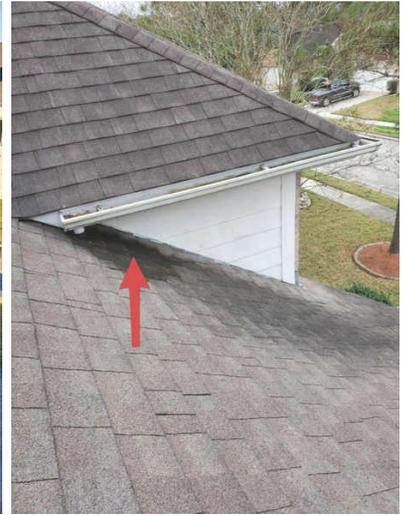
While this is not your roof, this depicts the damage that will be caused to your lower roof over time if the gutters are not routed to the ground

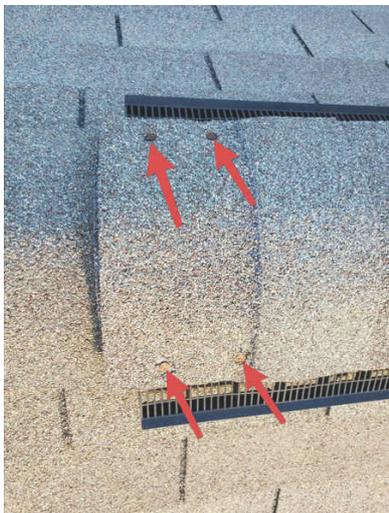
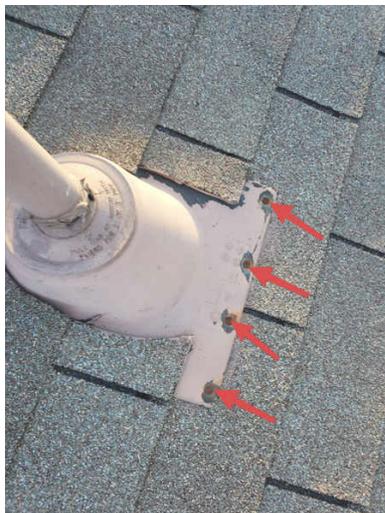
**1: Exposed Nails**

Under-driven or exposed nails were found in one or more roof coverings. This can lead to water intrusion which can cause rot, mold, structural and cosmetic damage. I recommend applying caulk over these exposed nail heads.

Nail heads should be caulked to prevent water intrusion

All roof penetrations should be sealed

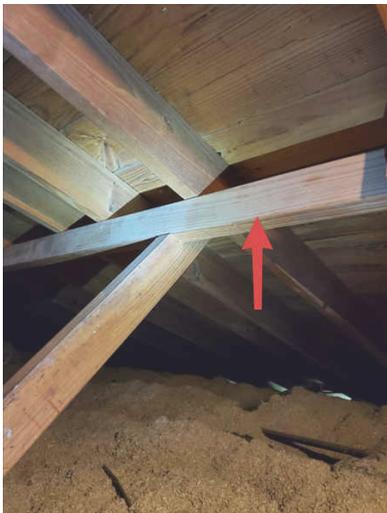
Purlins are required to be the same size as the rafters they are supporting. The rafters are 2x6 and the purlins supporting them are only 2x4. The roof is not currently showing any signs of movement. I would recommend monitoring this and upgrading purlins in the future when needed.

2x4 purlin supporting 2x6 rafter

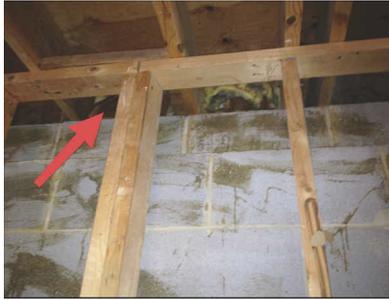
Fireblocking is required in detached garage breezeway to prevent a garage fire from spreading to the main house. This is a very important issue that should be resolved immediately. Due to how houses are designed to naturally draft air through the attic, if a fire starts in the garage it will be pulled through the breezeway and into the attic. This can be easily and cheaply avoided by installing a fire blocking material at the garage.

Fireblocking material should be installed here to prevent a garage fire from spreading to the rest of the house

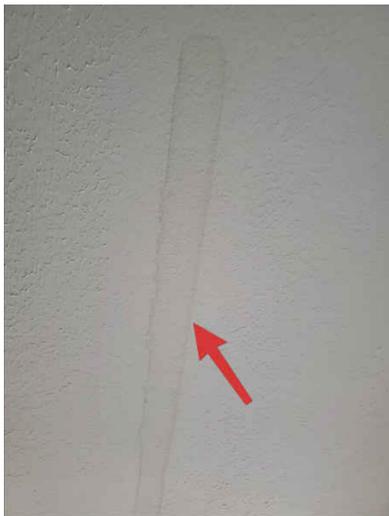
There were dark spots on the ceiling which indicate possible water intrusion. This did not appear to be an active leak and there was only minor discoloration observed. This should be easily painted over.

Water stain observed on ceiling

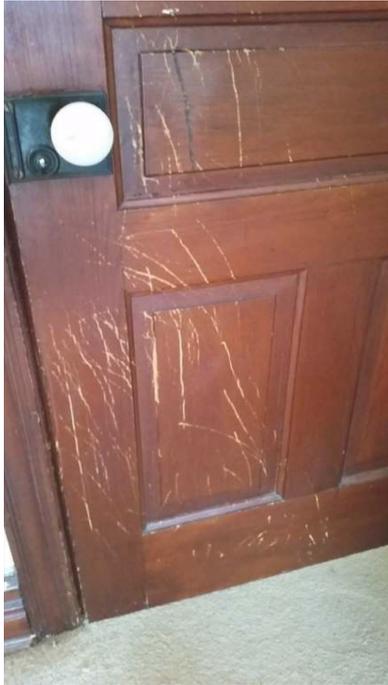
Door finish is damaged possibly from dog scratches. Recommend refinish and/or paint to maximize service life.

Scratched door needs to be refinished

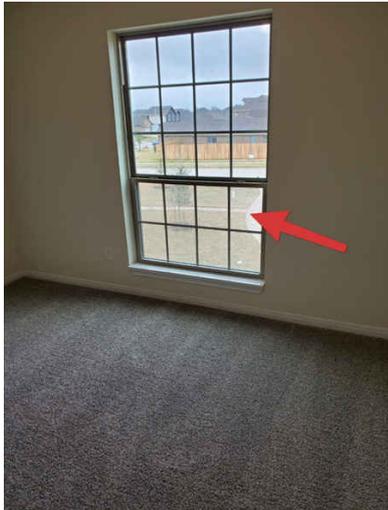
Windows on the second story that are this low to the floor should not be able to open more than 4 inches. Having this window open presents a fall hazard to children. A clamp should be installed that prevents this window from leaking more than 4 inches as this is a cheap and easy way to ensure the safety of children.

This window should not open more than 4 inches.

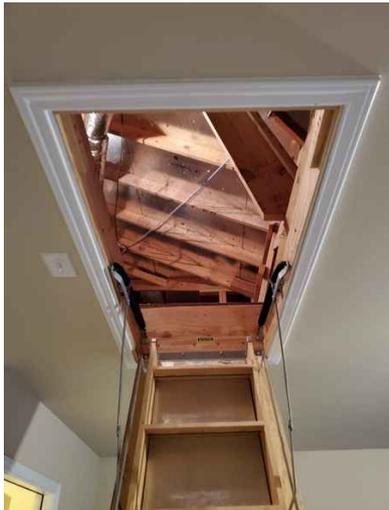
Attic stairs should be secured by 5 16D nails on each side and 3 16D nails front and back for a total of sixteen 16D nails. I recommend putting in the correct amount of nails.

Attic staircase should be adequately nailed into place

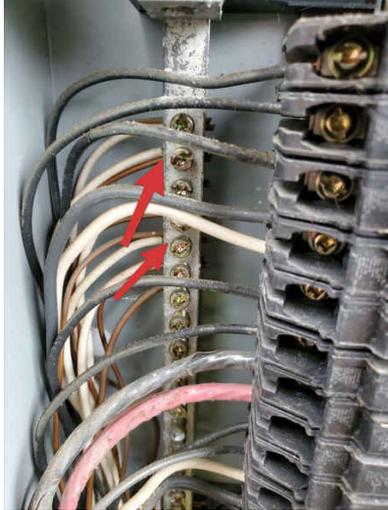
Double tapping of neutral wires is not allowed. Each neutral wire should have its own terminal. This is a common defect but it should be addressed the next time the electrical panel is serviced.

Double tapped neutral wire

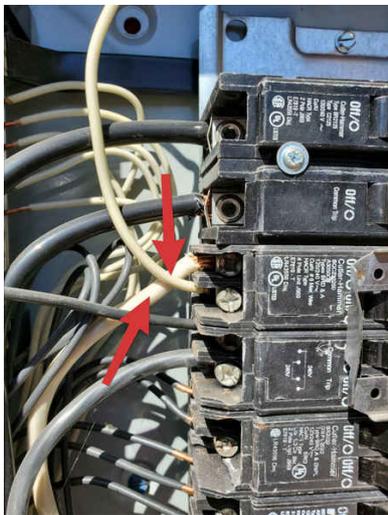
**2: White wire used as hot power wire**

Multiple white wires were used as power supply wires from breakers. While this is not forbidden, the white wires are supposed to be taped or marked black or red to avoid any confusion. These wires should be taped or colored appropriately to help avoid any accidents in the future.

White wire used as power wire

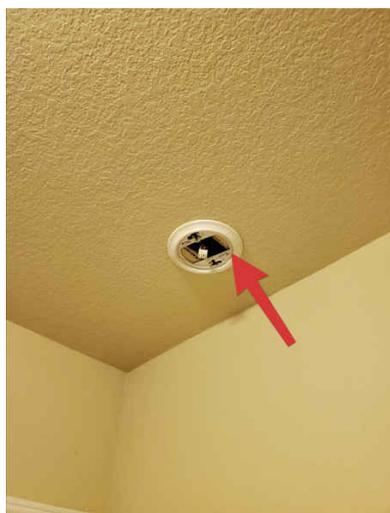
**1: Smoke Detector Missing**

Smoke detectors were not present in any bedrooms or outside all sleeping areas as required. Recommend installing smoke detectors in all bedrooms and outside all sleeping areas immediately as this is a cheap way to ensure the safety of your family

Missing smoke detector

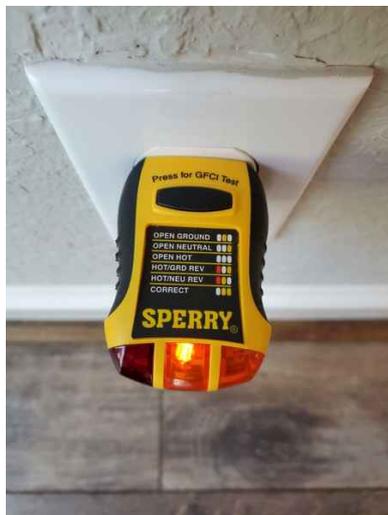
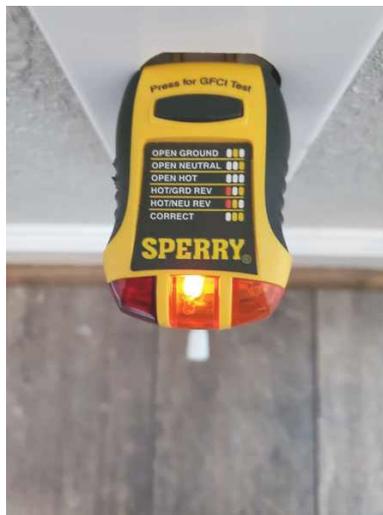
Multiple outlets throughout the house had an *Open ground*. This means there is no protection at the outlet providing a safe path back to ground for electricity. This is an issue that should be addressed as soon as possible by a licensed electrician because if there is a short in a device plugged into this outlet, it could pose a serious shock hazard.

Open ground in living room

Open ground in dining room

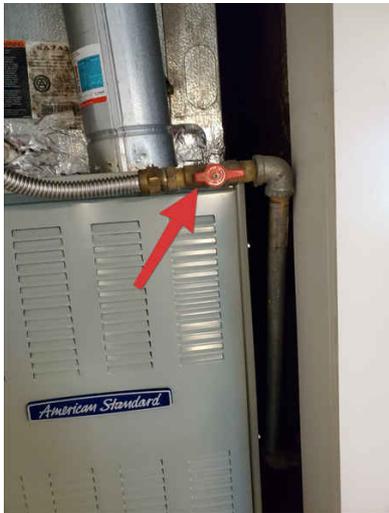
**1: No Sediment Trap Present**

The gas piping contained no sediment trap. Sediment traps or drip legs are generally required, depending on your local jurisdiction. The purpose of a sediment trap is to prevent particulates or moisture from entering and clogging the furnace gas supply, which could trip the furnace and possibly lead to an expensive service call. We recommend consulting a local licensed, qualified HVAC technician concerning sediment trap installation the next time this unit needs servicing. This is a cheap way to help avoid potentially costly repairs in the future.

No sediment trap

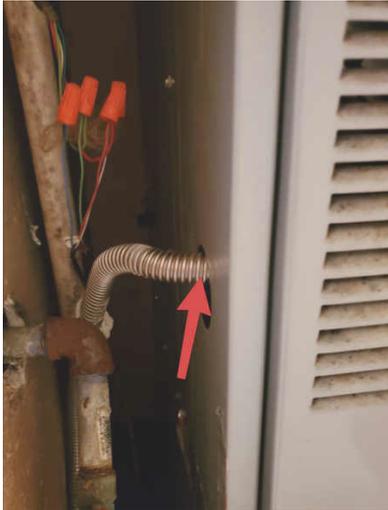
**2: Flexible Gas Line Extends Inside Cabinet**

Flexible gas lines should not extend inside the cabinet of the furnace. I recommend addressing this when the unit is serviced.

Flexible gas line goes inside furnace cabinet

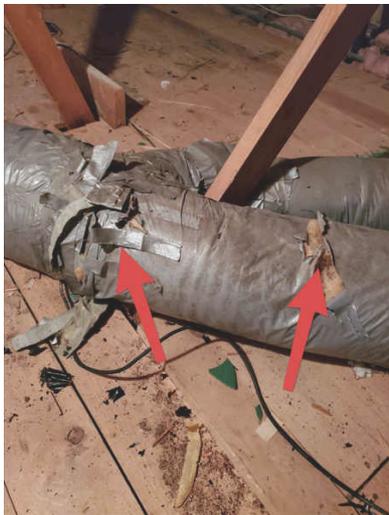
**1: Duct Damaged**

Air supply duct was damaged. Damaged ducts will reduce your cooling and heating efficiency and should be replaced or repaired at your earliest convenience.

Damaged duct

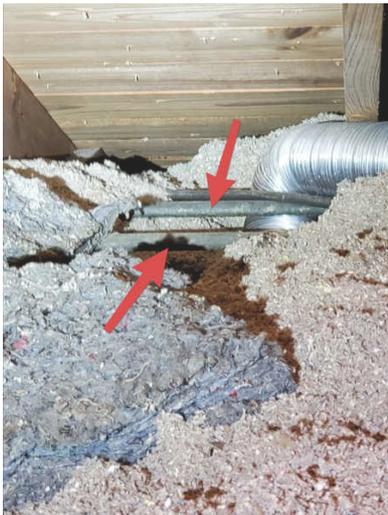
Metal piping should be insulated to protect from damage during a freeze. If these pipes burst, they will cause water damage to the ceiling and house below.

No insulation on piping in attic

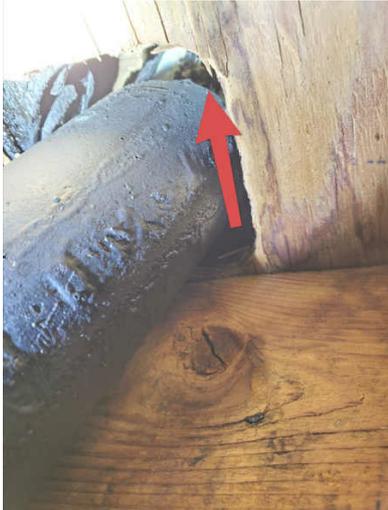
Vent terminates inside attic

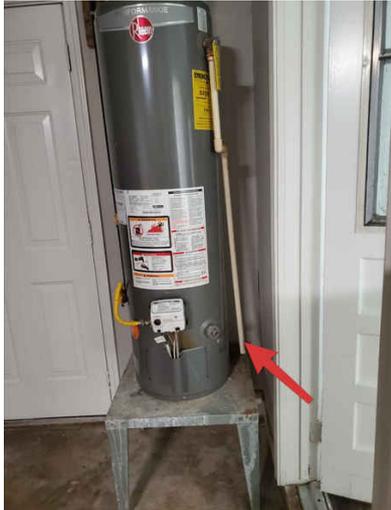
**1: Improper Termination of TPRV**

TPRV valves are required to terminate no more than 6 inches above the garage floor to prevent burns in the event hot water discharges from this valve. A diagram explaining this is included with these photos.

TPRV valve discharge pipe should terminate within 6 inches of the garage floor

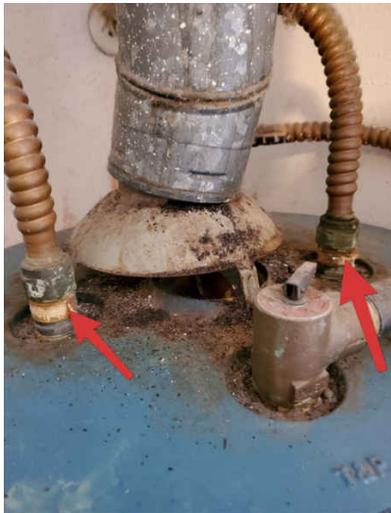
**2: Rusted Connections**

Connections at water heater are corroded. These should be replaced at your earliest convenience to prevent them from forming leaks.

Corroded connections

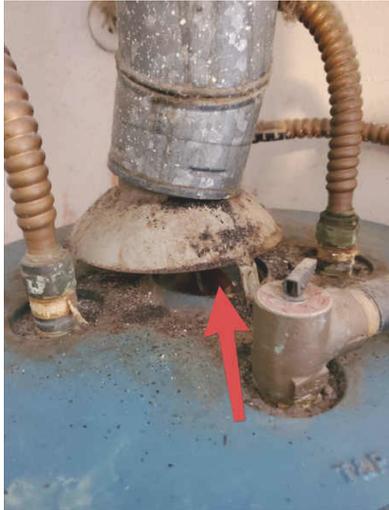
**3: Exhaust flue improperly aligned**

The exhaust flue from the water heater is improperly aligned. This will let exhaust gases into the attic instead of being carried out through the roof. This vent should be properly secured into place.

Exhaust flue not properly aligned

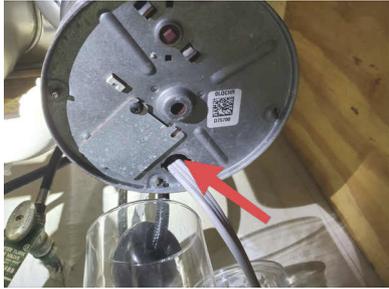
Missing wire nut

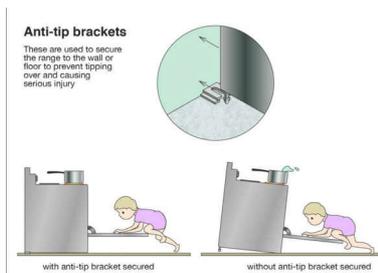
**1: No Anti-Tip Device Present**

Anti-tip brackets should be installed to protect children from accidentally tipping a stove over.

Anti-tip devices prevent these accidents from happening

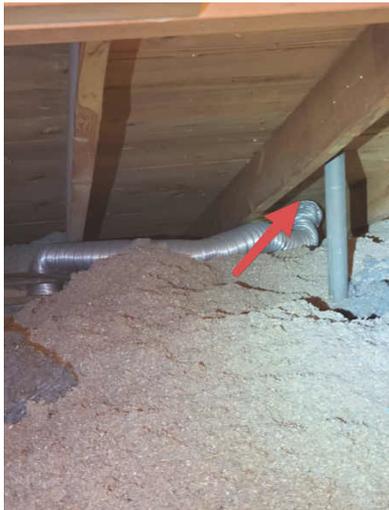
**1: Improper Venting**

Improper venting practices were noted. Bathroom exhaust vents should terminate outside the home, not inside the attic. These vents should be routed to the exterior of the home at your earliest convenience.

Vent terminates in attic
